Name Of Dam: HUNGRY MOTHER STATE PARK DAM

Location: SMYTH COUNTY, VIRGINIA

Inventory Number: VA 17309

# PHASE I INSPECTION REPORT

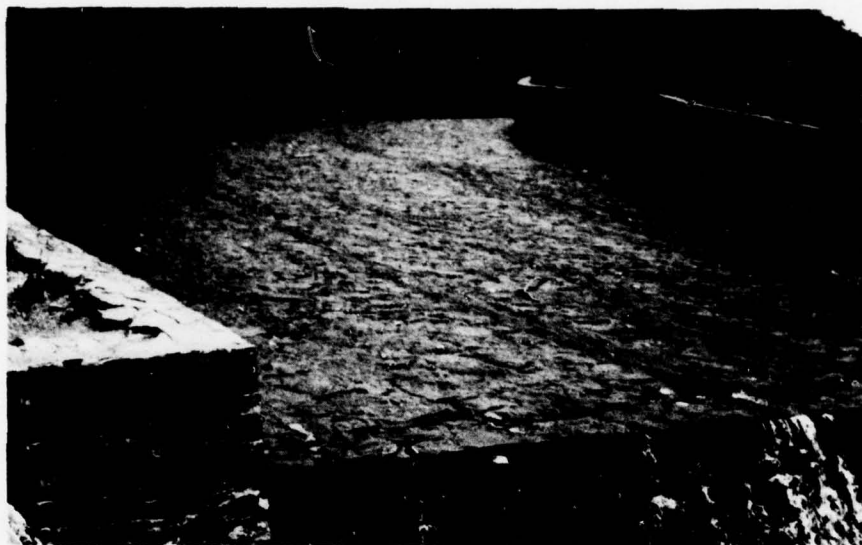
VIEW FROM BOTTOM OF SPILLWAY CHUTE
